Manhole Inspection Summary

Manhole # S39GG1015MH

Insp Date: **8/28/07 2:11 PM**

Location Address: **618 WYANOKE AVE**

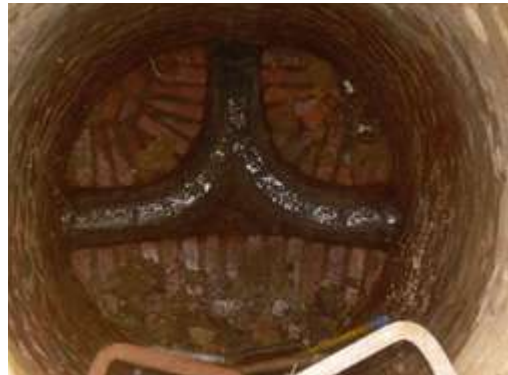
Top View

Corroded steps. Bench debris.

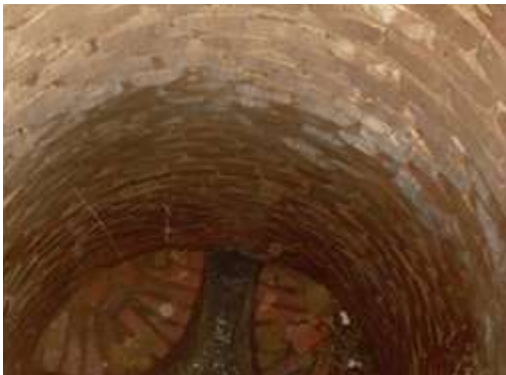
Defect

Corbel and Barrel infiltration. Corbel deterioration.

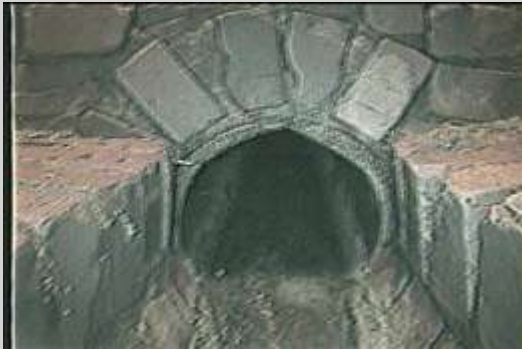
8 in. Circular Gravity Sewer Pipe Out @ 12 O'Clock

Deposits: ☐ None ☒ **Mud** ☐ Sludge ☐ Debris ☒ **Grease**

Infiltration: **Evidence** Pipe Seal Cond: **Unknown**

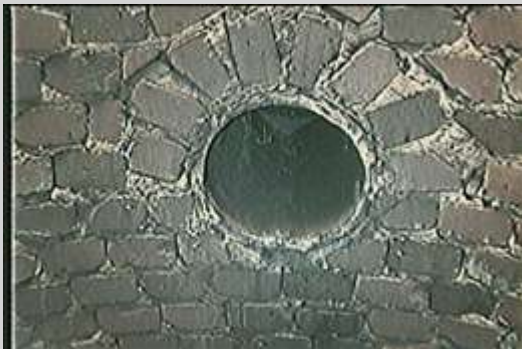
8 in. Circular Gravity Sewer Pipe In @ 3 O'Clock

Barrel infiltration and deterioration.

Infiltration: **Evidence** Pipe Seal Cond: **Cracked**

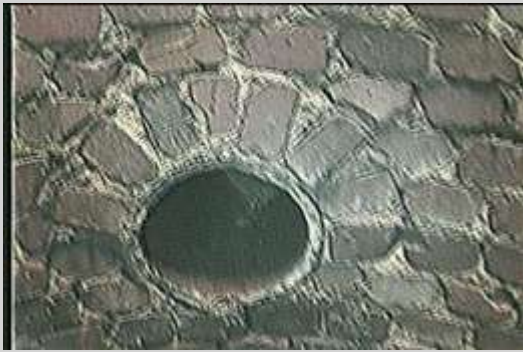
Pipe In @ 9 O'Clock

Barrel infiltration and deterioration.

Infiltration: **Evidence** Pipe Seal Cond: **Broken**

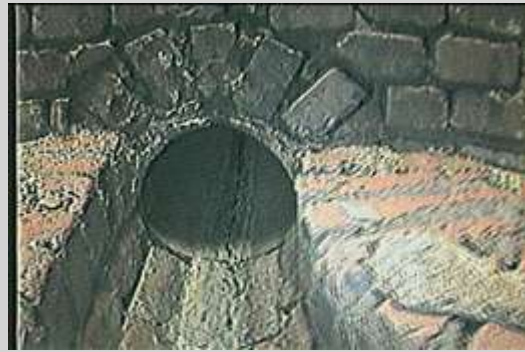
Drop In @ 9 O'Clock

Barrel deterioration and infiltration. Channel deterioration.
